GRAMPA'S BROWNS CORNER

MOWER DECK SPECIAL

You have no doubt wondered about Grampa's experience with the Radtech LM3560A mower deck installed on his LS XJ2025H tractor, delivered during Browns Corner Camp 2017. Overall, the experience has been AWESOME.

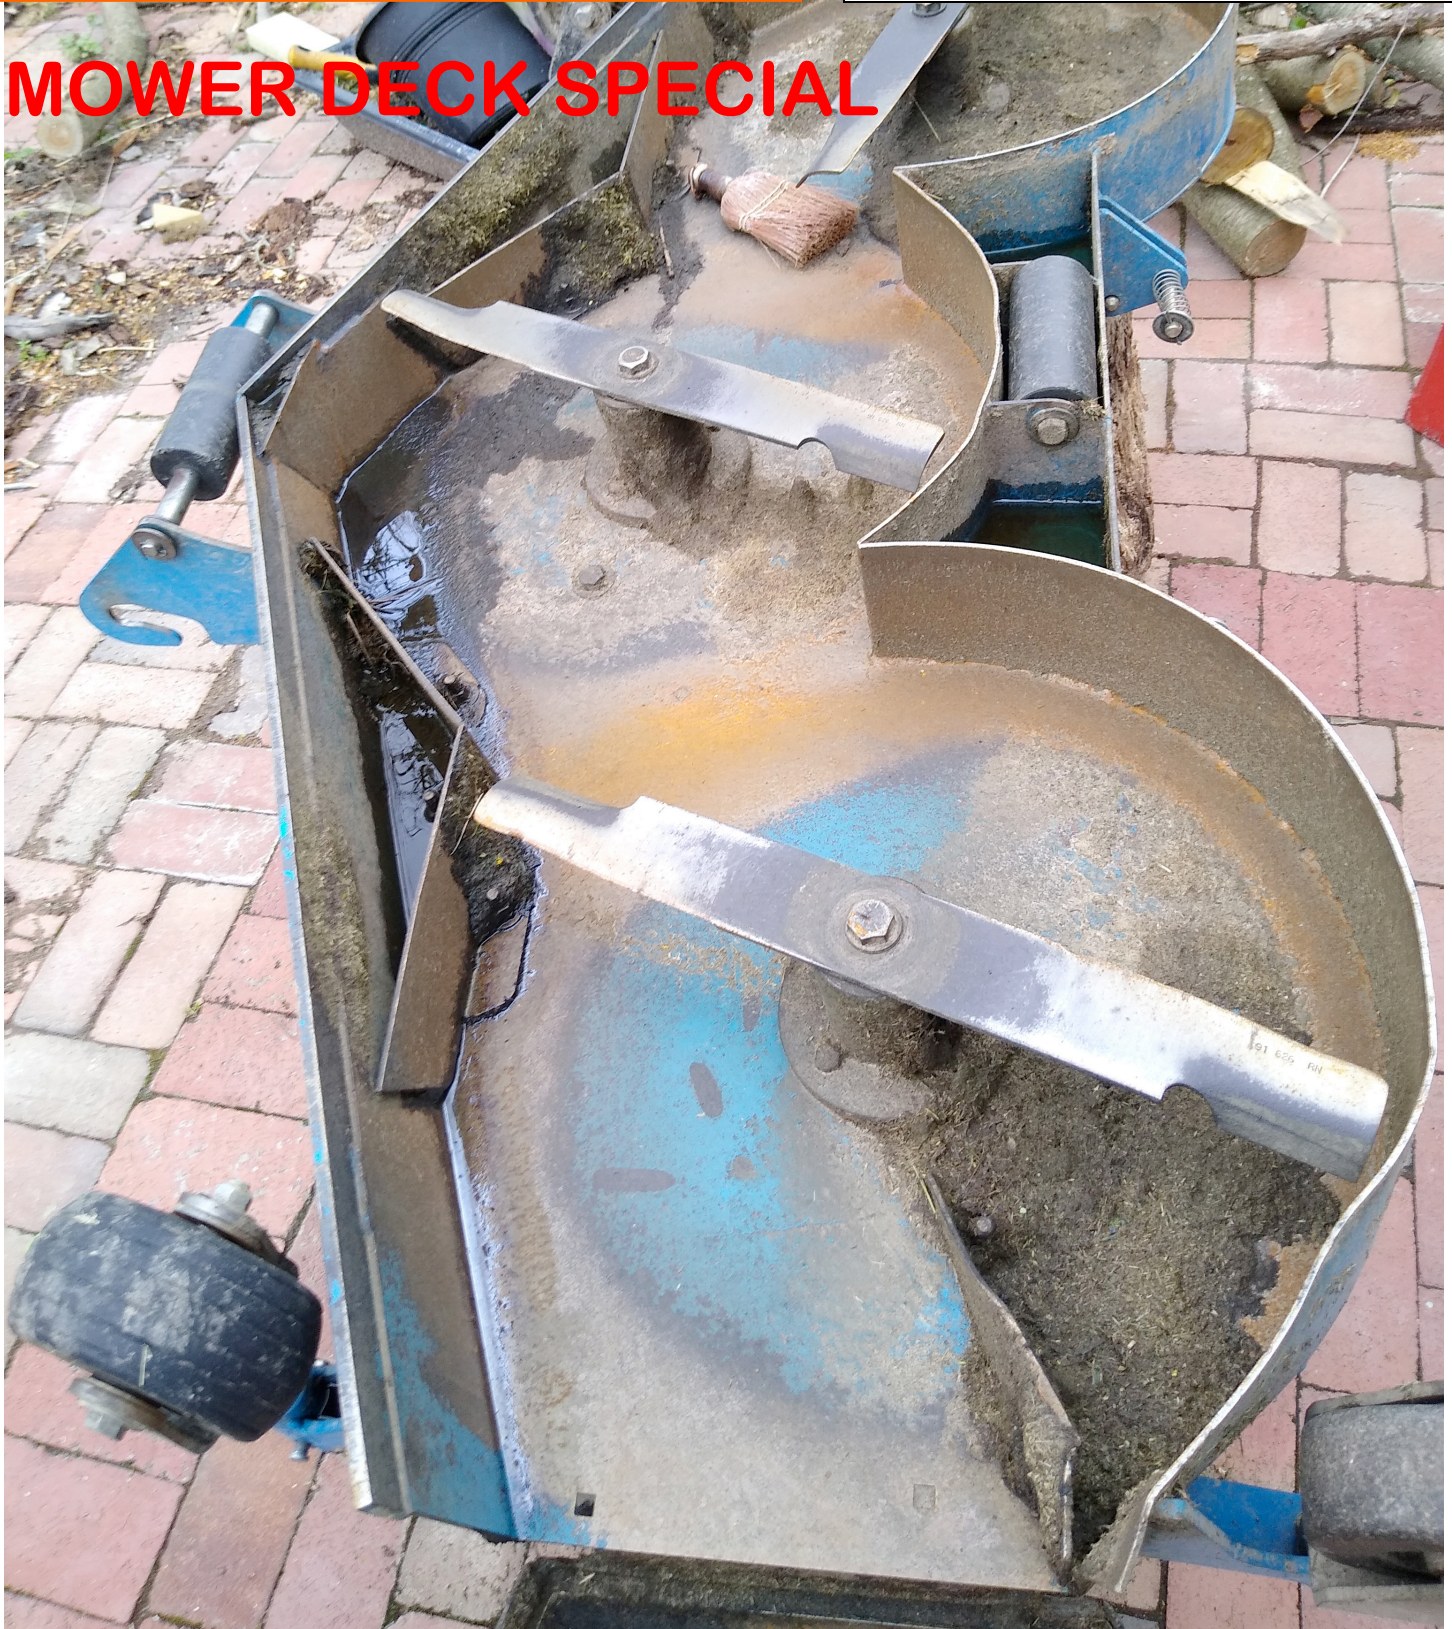
Mowing time for trimming the greens at Browns Corner has been cut in half as compared to the old John Deere tractor, partly due to a six inch wider mower and partly because the LS goes faster. Now, after three years, I decided it was time for some maintenance; the blades needed sharpening and i needed to replace the grease fitting expender tube for the center (drive) spindle.

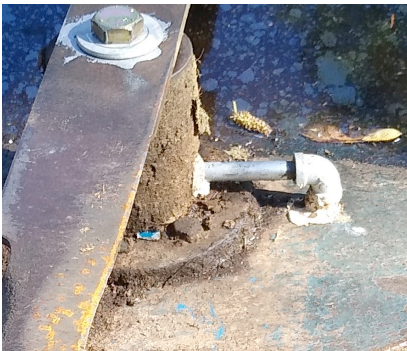
I thought about calling the dealer to come pick it up and do the maintenance but decided to save about \$300 by doing it myself. After removing the mower deck and turning it upside down, I was immediately struck by what generally good condition it was in. I'm pretty hard on mowers, don't balk at driving over branches up to about 2 inches in diameter, and occasionally run over bricks and scrap iron. After three years the old John Deere deck was pretty beat up. Not so with this one. In the picture you can see at lower right a couple of bent places but generally good, clean and rust free. Must be a high copper steel.

I had no trouble replacing the grease fitting extender using some black iron plumbing fittings and some JB Weld epoxy putty. But sharpening the blades was a bit more trouble.

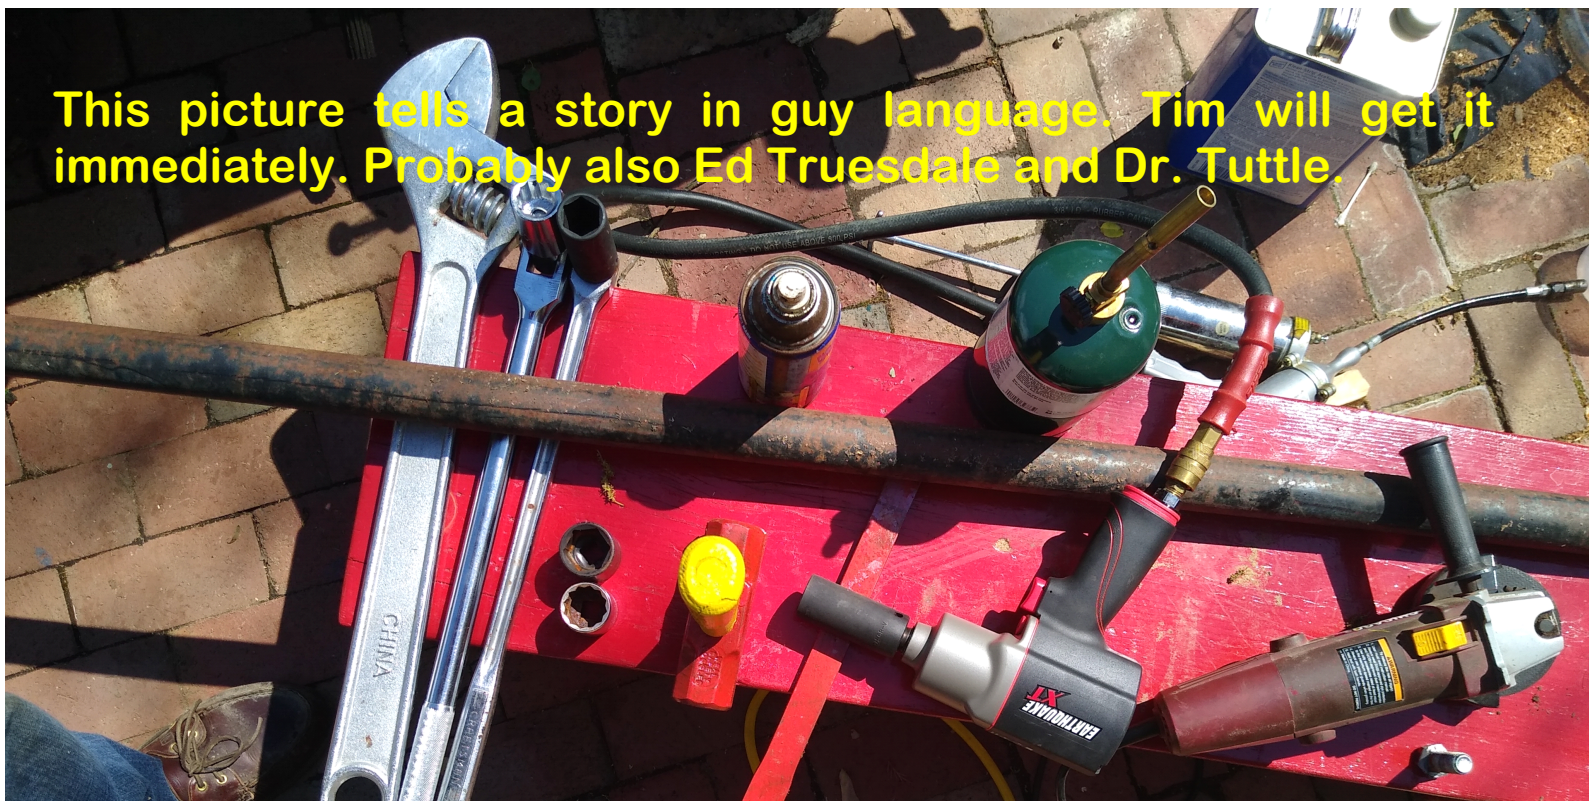
This picture tells a story in guy language. Tim will get it immediately. Probably also Ed Truesdale and Dr. Tuttle.

I started with WD-40 and a very large 24" adjustable wrench. Could not turn the bolt on the center spindle. Then I went to a 24" breaker bar with a six-point socket. No good. I put a six-foot pipe on the breaker bar. Nothing.

I got out my Bernz-O-Matic torch, tried heat. Nope. I made a block of ice to cool the blade before heating the bolt. Pneumatic impact wrench set on max. No.

On the right you see the mini grinder with cut-off wheel. I simply cut the washer out from under the bolt. A little help with a cold chisel and I was home free.

I stopped at the hardware store for some *anti-seize compound* figuring that maybe my axle grease technique was no good. I also bought three new bolts and washers. Had to replace at least the one I cut out with the grinder.

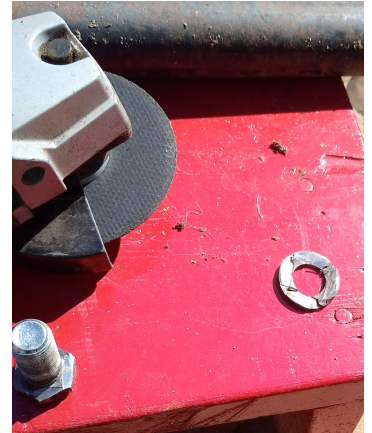
While I was cleaning up the spindles for reassembly I discovered the root cause of my problem. Last time the blades were sharpened late summer of 2018, I had the dealer do it. Apparently the mechanic was confused because the threads and faying surfaces were coated with *thread lock compound*, intended to prevent threads from turning. Dummy.

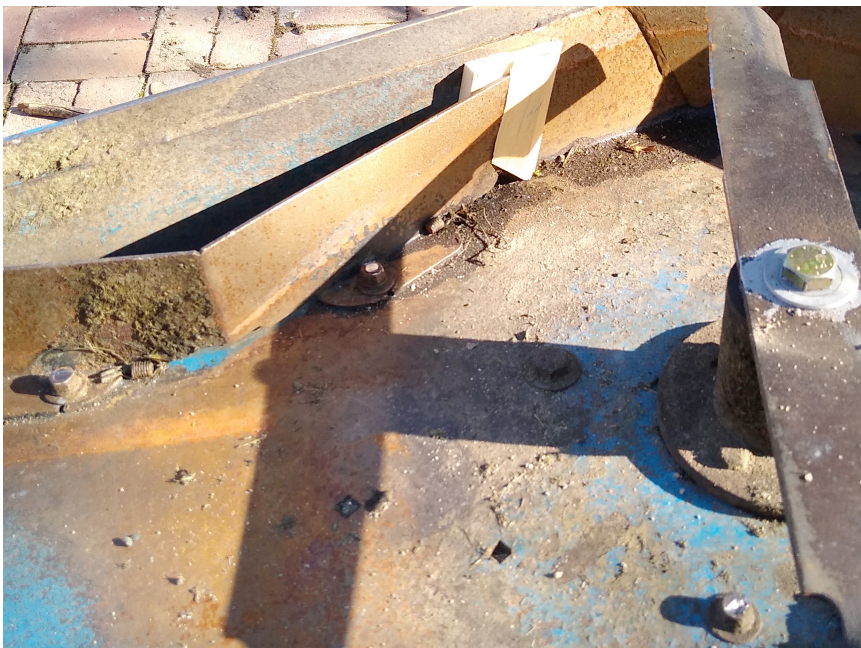
I noticed several bolts which stuck down into the clipping flow by about an inch. Silly. I cut them back with the mini grinder, flush with the nuts. You can see I swabbed up the spindle bolts and washers with *anti-seize compound*.

I also fitted a wood block to fair the end of that grass barrier (behind the shadow of the blade at top of picture).

Straightened the couple bent places and good to go.
